Test Report No. SHAEC2214790803 Date: 21 Oct 2022 Page 1 of 4

Sample Name: 3M 9731-50 Model No.: 3M 9731-50 Client Ref. Information: 3M 9731-100

Test Requested: Selected test(s) as requested by the client.

<u>Halogen</u>

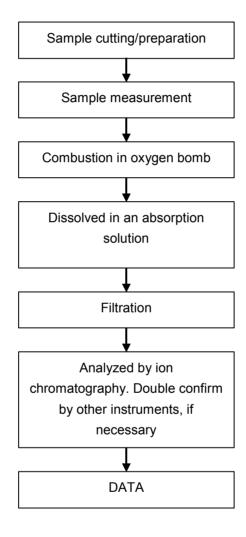
Halogen Testing (oxygen bomb) Flow Chart

Test Method: With reference to EN 14582: 2016, analysis was performed by IC.

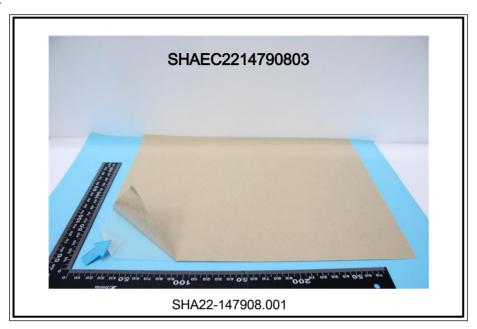
Sample photo:

SN1 SHA22-147908.001 Translucent adhesive tape
