Test Report No. SHAEC2211738403 Date: 15 Aug 2022 Page 1 of 4

Sample Name : 3M 57801 Model No. : 3M 57801

Halogen Testing (oxygen bomb) Flow Chart

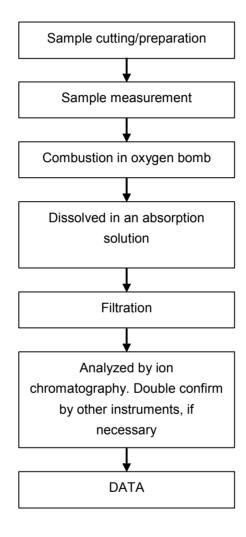
Test Method: With reference to EN 14582: 2016, analysis was performed by IC.

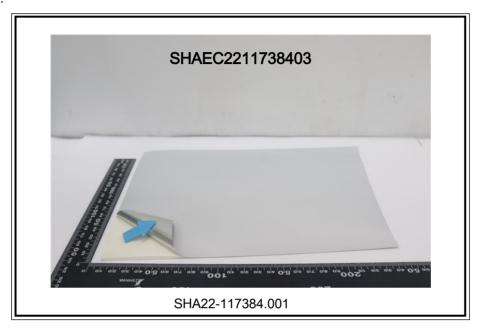
Sample photo:

SN₁ SHA22-117384.001 Silvery adhesive soft solid sheet
