Test Report No. SHAEC2211736103 Date: 15 Aug 2022 Page 1 of 4

Sample Name : 3M 7871 Model No. : 3M 7871

<u>Halogen</u>

Test Method: With reference to EN 14582: 2016, analysis was performed by IC.

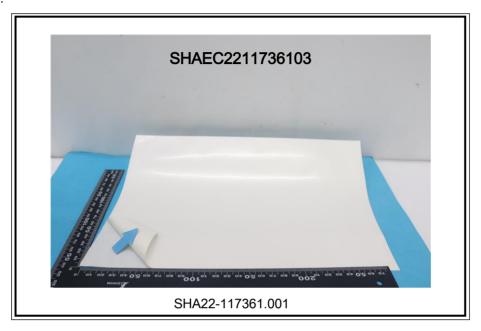
Sample photo:

SN₁ SHA22-117361.001 White adhesive soft solid sheet
