Test Report No. SHAEC2212626703 Date: 31 Aug 2022 Page 1 of 4

Sample Name: 3M FP035402 Model No.: 3M FP035402

Test Method: With reference to EN 14582: 2016, analysis was performed by IC.

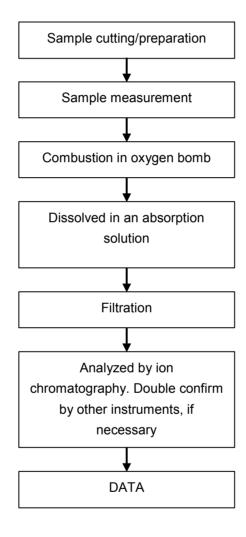
Halogen Testing (oxygen bomb) Flow Chart

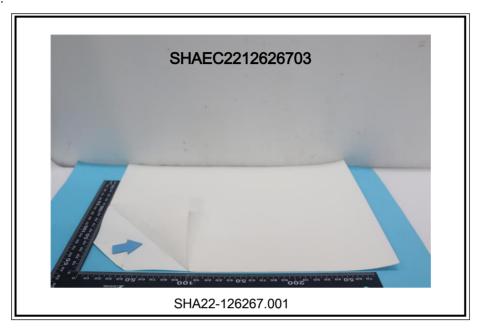
Sample photo:

SN1 SHA22-126267.001 White adhesive soft solid sheet
