Test Report

No.: CANEC23011795501

Sample Name: 9772WL

Halogen

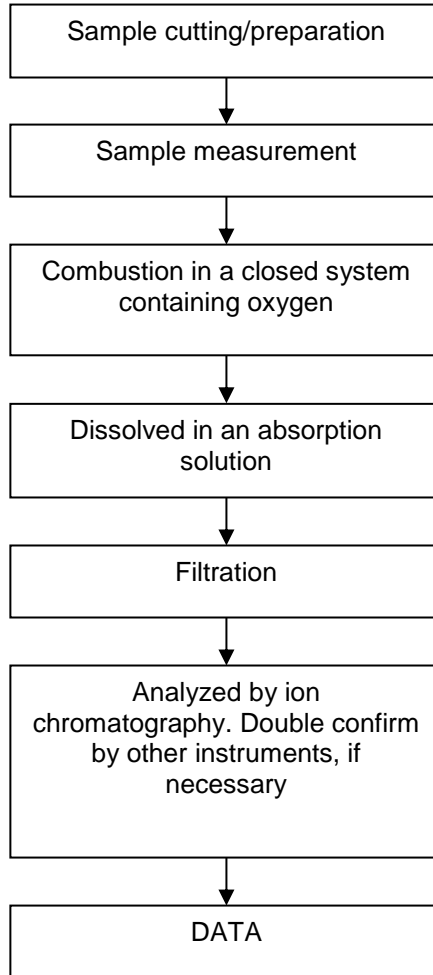
Halogen Testing Flow Chart

Test Method: With reference to EN 14582:2016, analysis was performed by IC.

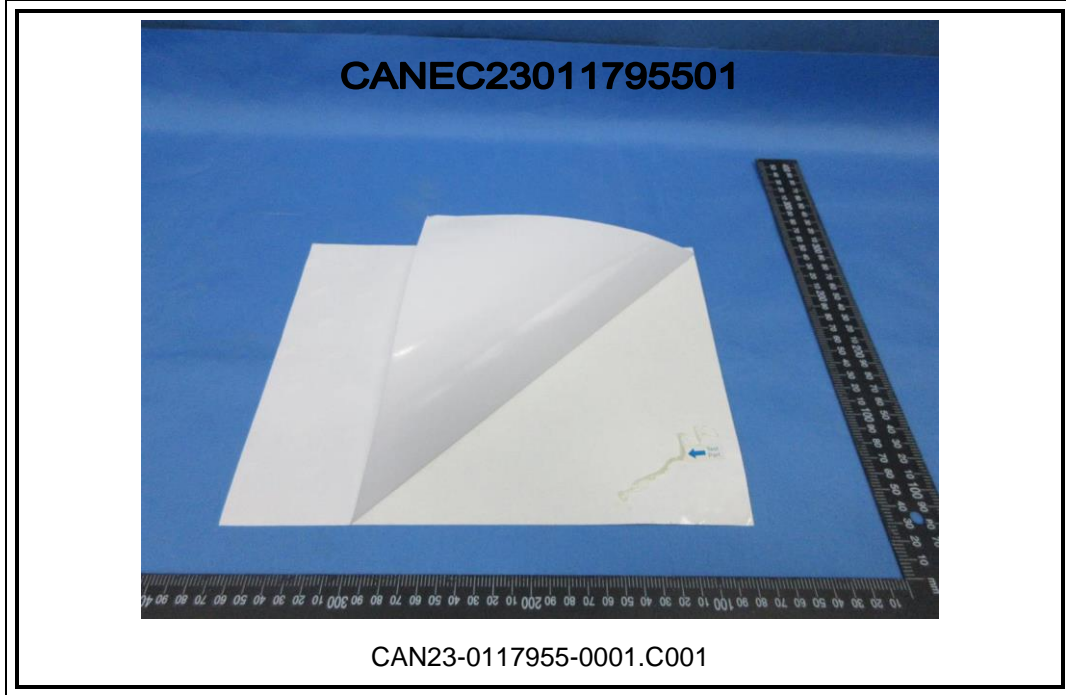
Sample Photo:

SN ID	Sample No.	SGS Sample ID	Description
SN1	A1	CAN23-0117955-0001.C001	Colorless transparent double-side adhesive sheet
